Appendix B.

Vegetation and Shade Analysis for Scenario Development

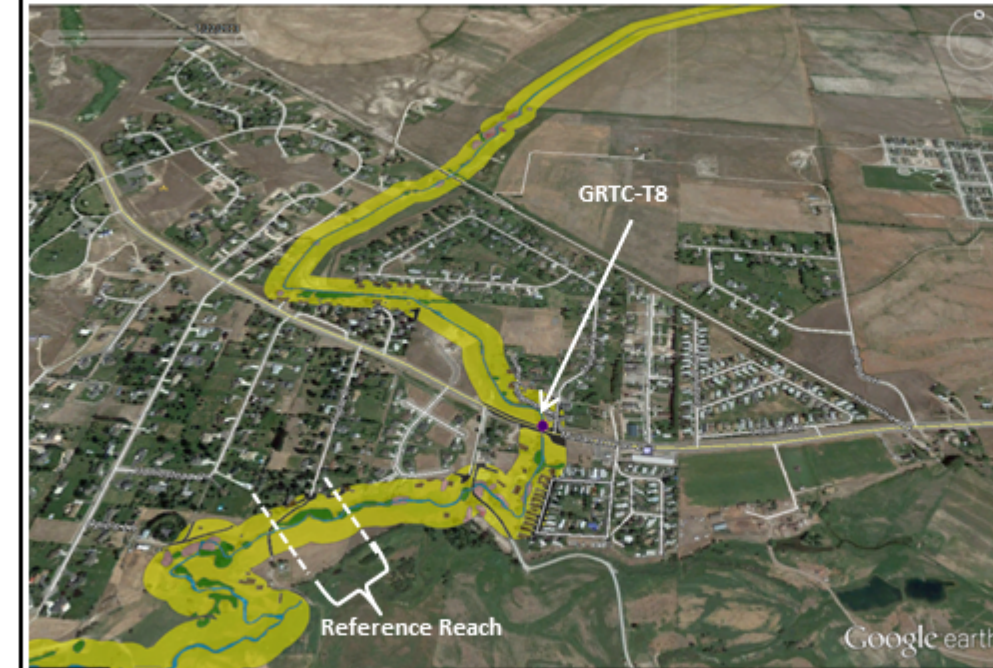
Proposed Shade Scenario: Use the reach downstream from GRTC-T8 as a reference (shown to left) and apply reference shade (approximately 59% average daily) to this entire reach.

Note that the reference reach is comprised of an approximate 25' buffer of shrubs.

Summary of Existing Condition: From Hwy 200 downstream to the mouth, Grant Creek flows through the Clark Fork River valley in an area of mixed agricultural, residential, and commercial land uses. Based on air photo analysis, there appears to be significant opportunity to improve shade in the agricultural areas (i.e., introduce a vegetated buffer comprised of shrubs or trees where none currently exist).

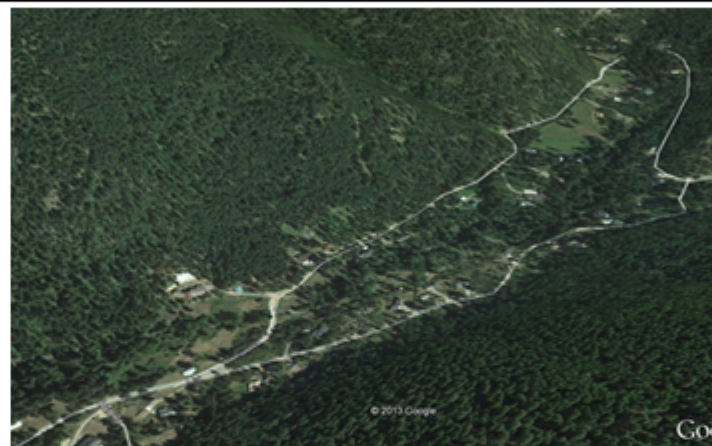
Summary of Existing Condition: From GRTC-T4 downstream to Hwy 90 (just downstream from GRTC-T6) Grant Creek flows through the foot hills down to the Clark Fork River valley bottom. Where the riparian corridor has been un-impacted by encroachment from agriculture, power lines, and subdivisions, it is comprised of predominantly moderate to low density mixed deciduous and coniferous trees. There appears to be some limited opportunity to improve shade in this reach by converting some (but not all) of the current herbaceous areas to shrubs or trees.

Proposed Shade Scenario: Use the reach just upstream from GRTC-T5 as a reference (shown below) and apply reference shade (approximately 69% average daily) to this entire reach.

1. Shade is at potential upstream from GRTC-T1.
2. Shade has been degraded slightly between GRTC-T1 and GRTC-T4. However, there is little that can be done to improve conditions given current development.
3. The "natural" condition for the riparian corridor between GRTC-T4 and GRTC-T6 is likely moderate to low density mixed deciduous/coniferous trees. There is some opportunity to improve shade in this reach, but only in discrete areas. Apply reference shade (approximately 69% average daily shade) to this reach for the shade scenario.
4. The riparian corridor downstream from Hwy 200 has been highly degraded and there is significant opportunity to improve shade. Apply reference shade (approximately 59% average daily shade) to this reach for the shade scenario.
